PA/VSİ Or RFA FILE REVIEW CHECKLIST

Facility Name: GMC Cadillac Motor Car Clark Plt _____

**PRELIMINARY ASSESSMENT/
VISUAL SITE INSPECTION**

FINAL REPORT

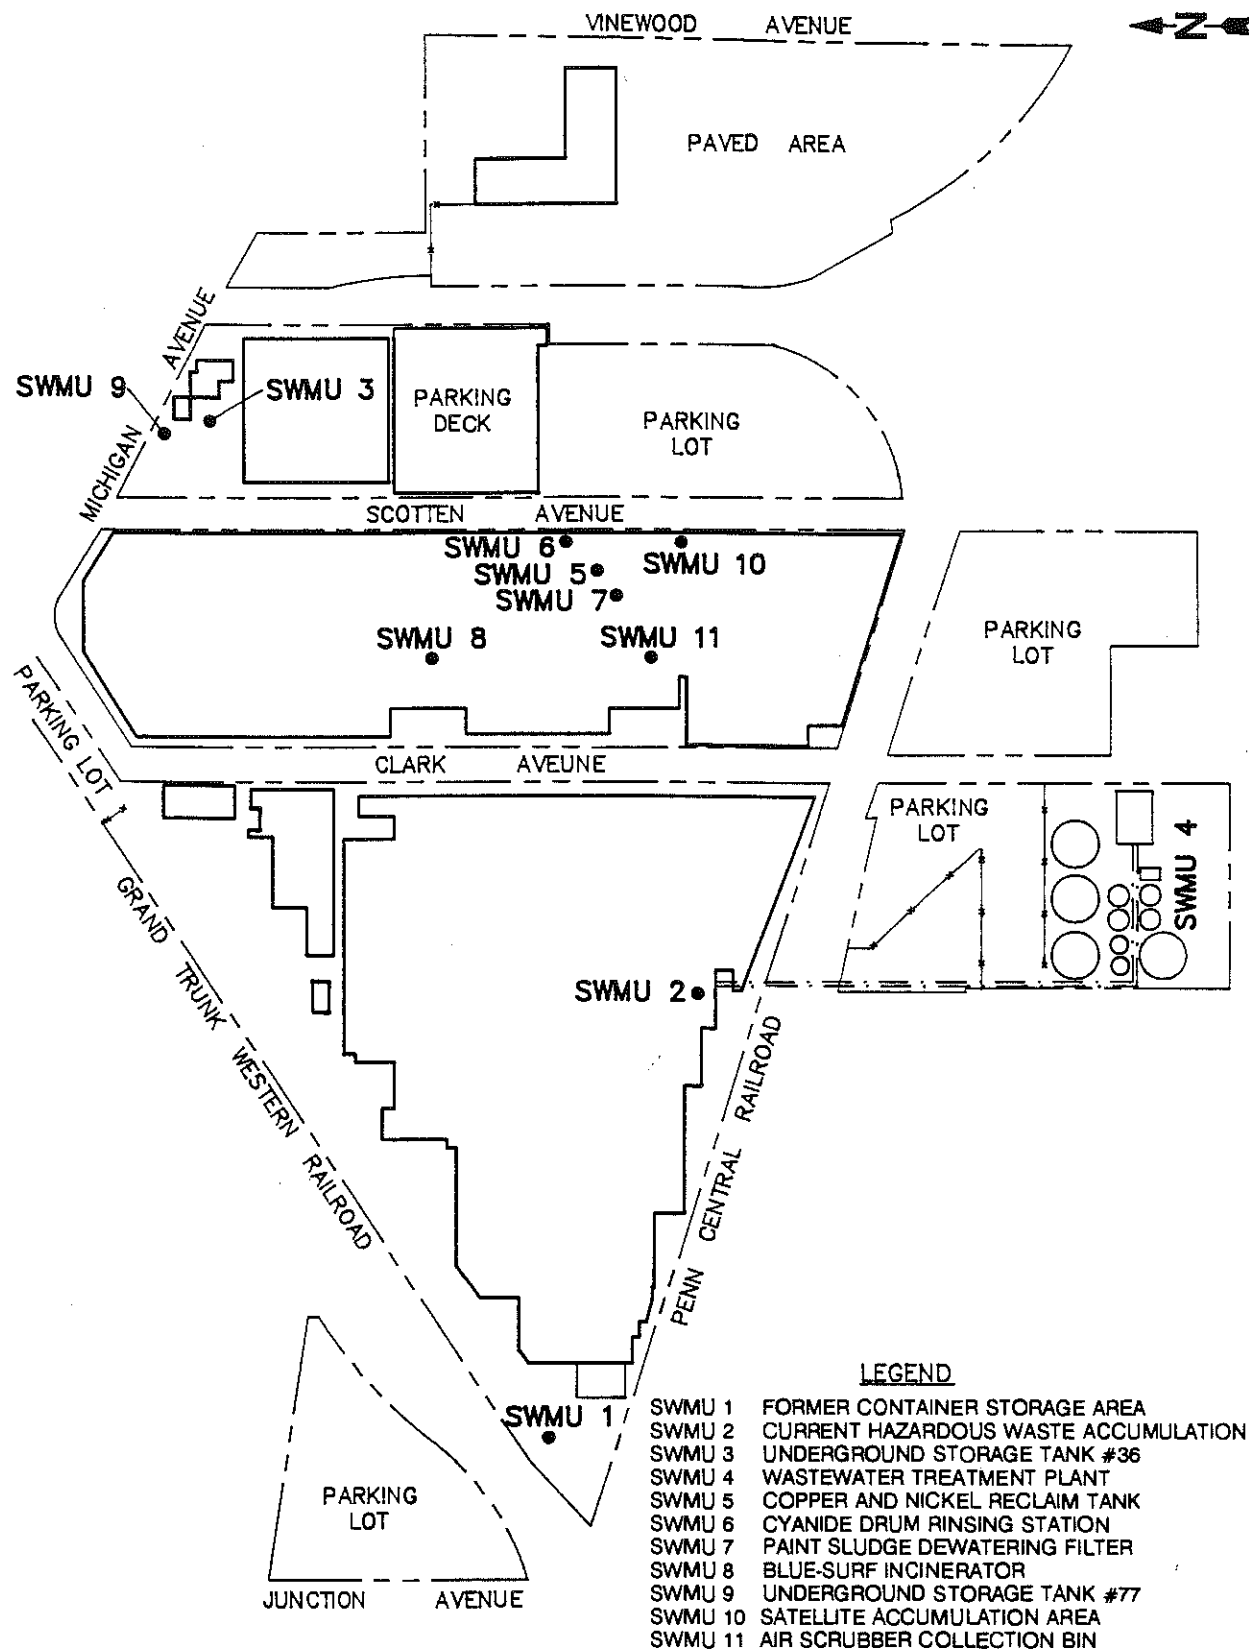
FIGURE 2
FACILITY LAYOUT

GMC CADILLAC MOTOR CAR-CLARK PLANT
DETROIT, MICHIGAN

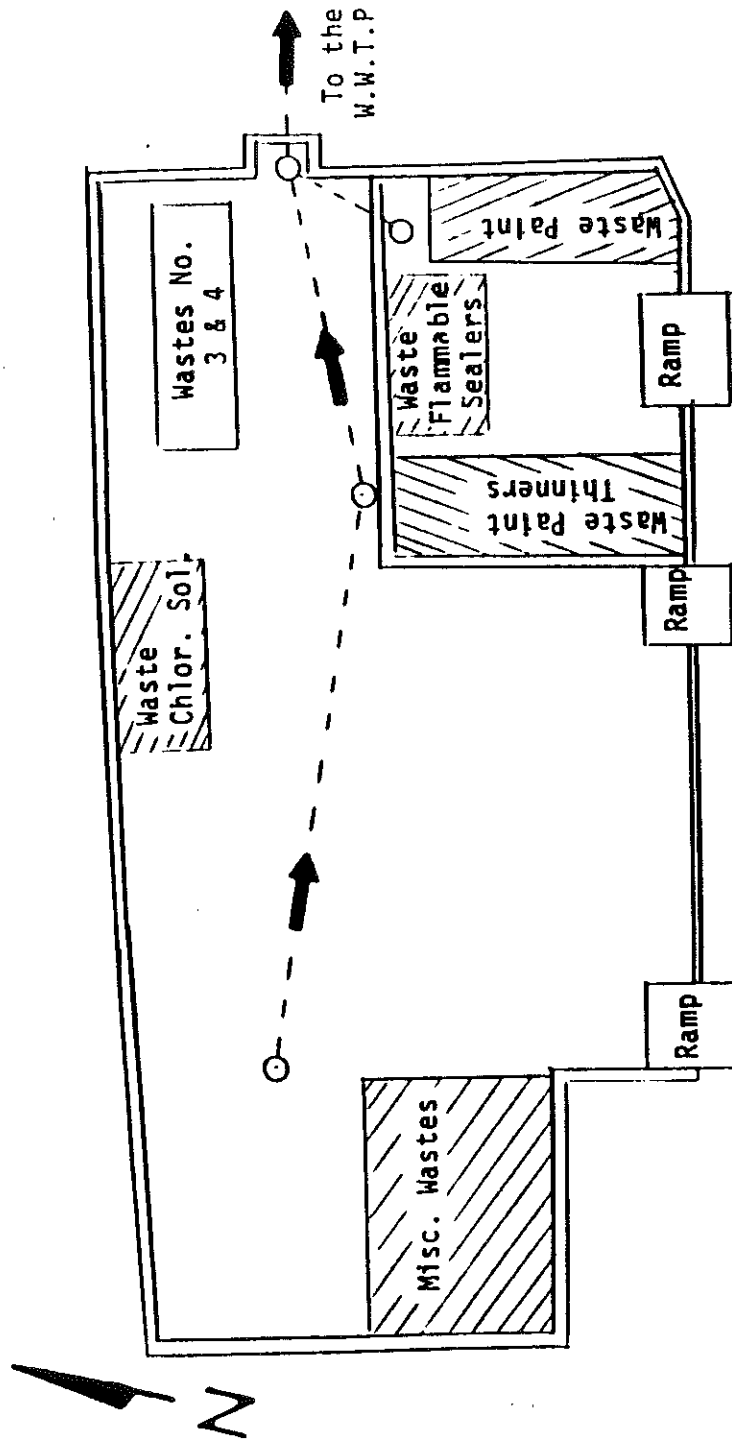
FIGURE 3
LAYOUT OF FORMER CONTAINER STORAGE AREA

Unit Description: GMC previously stored various containers of both hazardous and nonhazardous wastes in a paved and bermed area, 110 feet wide by 330 feet deep, next to the parking lot at the west perimeter of the facility and adjacent to the Grand Trunk Western Railroad. The former storage area consisted of three separate container management activities, as shown in Figure 3 and photographs 1 and 2 in Attachment A. GMC stored empty drums in one section of the container storage area. In another section, GMC stored miscellaneous nonhazardous wastes. The third section of the storage area was used to store RCRA hazardous wastes. The storage area was sloped toward a drain that conveyed precipitation runoff and spills to the wastewater treatment plant (SWMU 4).

Observations: GMC was not storing any wastes inside the storage area at the time of the VSI. The concrete berm and drains were still present. PRC noted the presence of grouted holes inside and adjacent to the container storage area; these holes resulted from closure sampling activities.

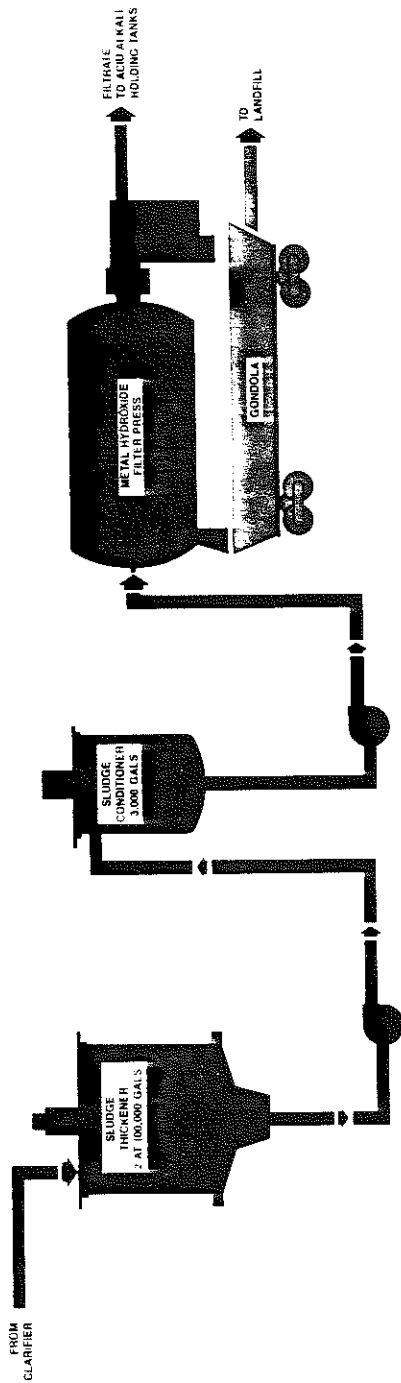
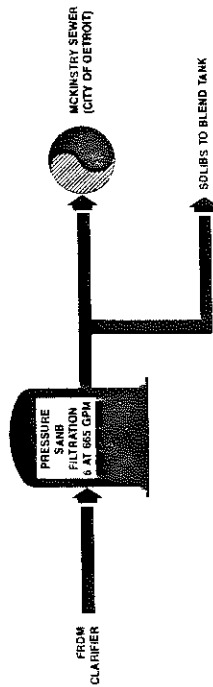
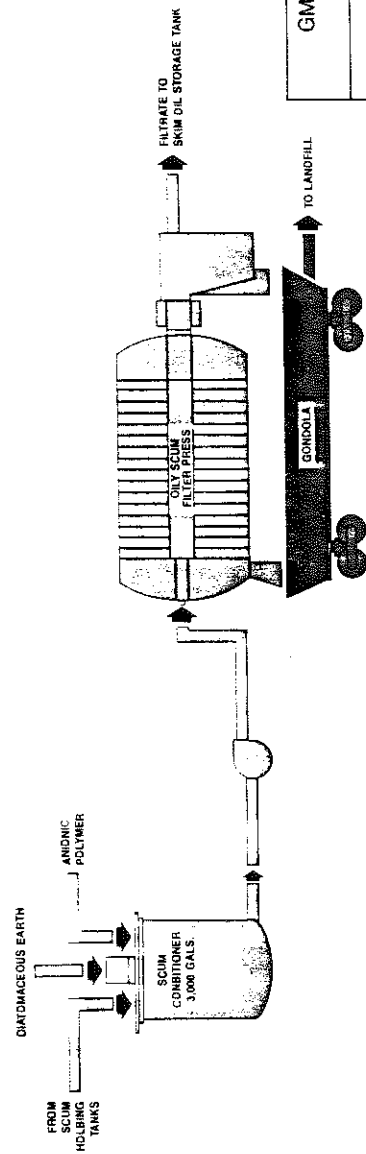
FIGURE 6
FILTRATION WASTEWATER TREATMENT PROCESS

Observations: All tanks observed during the VSI were in good condition, without any corrosion or cracks. No spills were observed near any of the tanks or other unit operations.

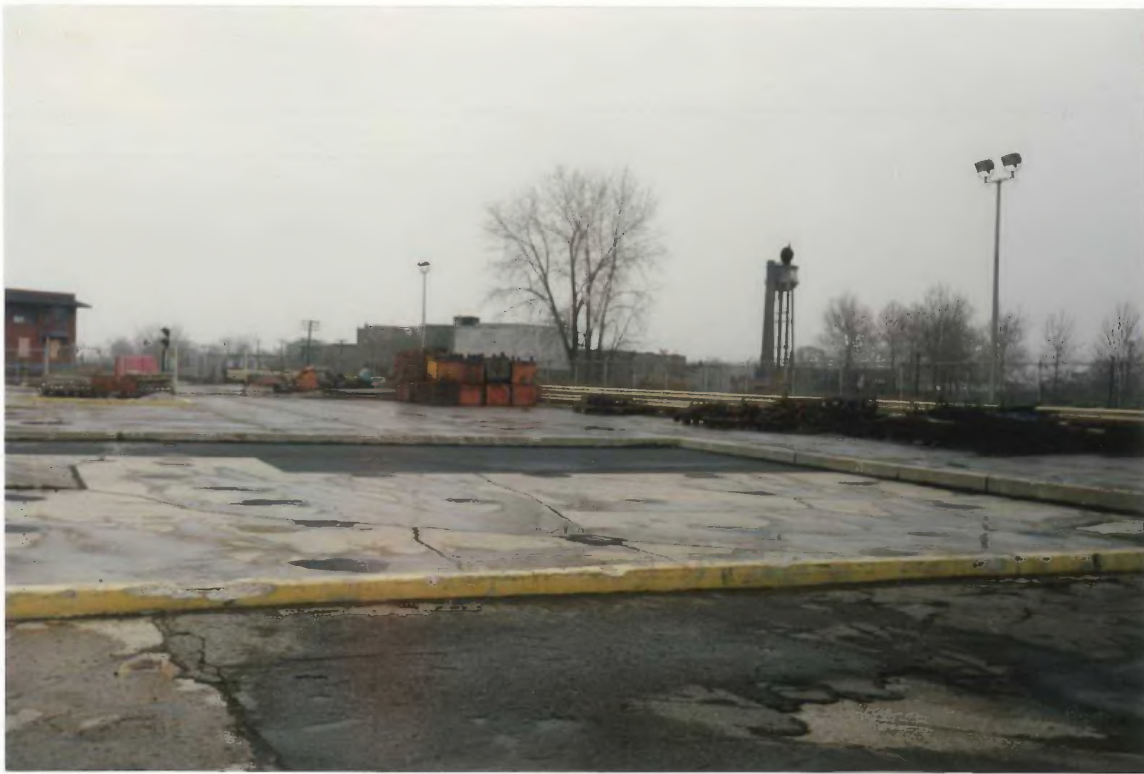
History of Release: GMC discovered soil contamination (volatile organic compounds present at one-foot beneath the storage pad) during closure of the unit. GMC subsequently investigated the area and determined the presence of various solvents (ethyl benzene; methylene chloride; toluene; 1,1,1-trichloroethane; methyl ethyl ketone; and xylenes [all isomers]) in the soils underlying the pad (GMC, 1990a). GMC requested and received a 180-day extension of the closure period of the storage area so they could assess the extent of contamination (MDNR, 1990).

Photograph No.	1	Location:	SWMU 1
Orientation:	West	Date:	11/15/91
Description:	Former container storage area; patched holes inside bermed area resulted from sample borings

Recommendations: PRC recommends the excavation and removal of contaminated soils associated with the former container storage area, as described in GMC's remedial action plan once the plan is approved by MDNR.

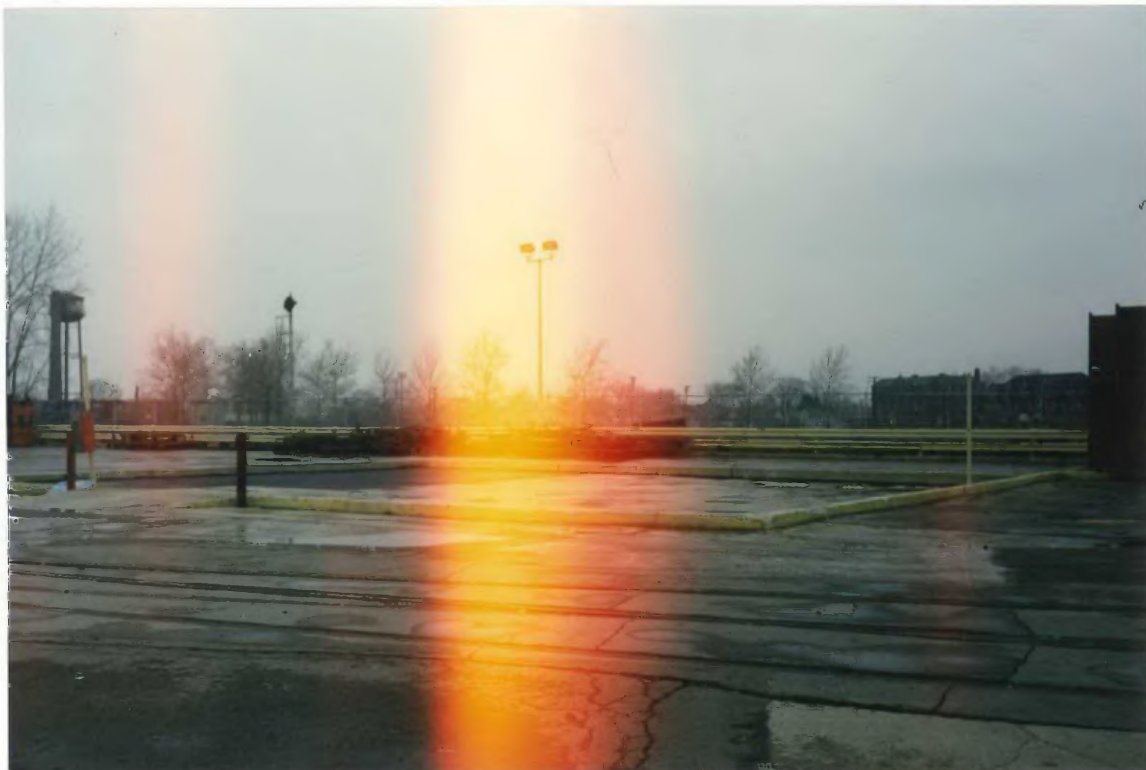
Photograph No.	2	Location:	SWMU 1
Orientation:	North	Date:	11/15/91
Description:	View of former container storage area

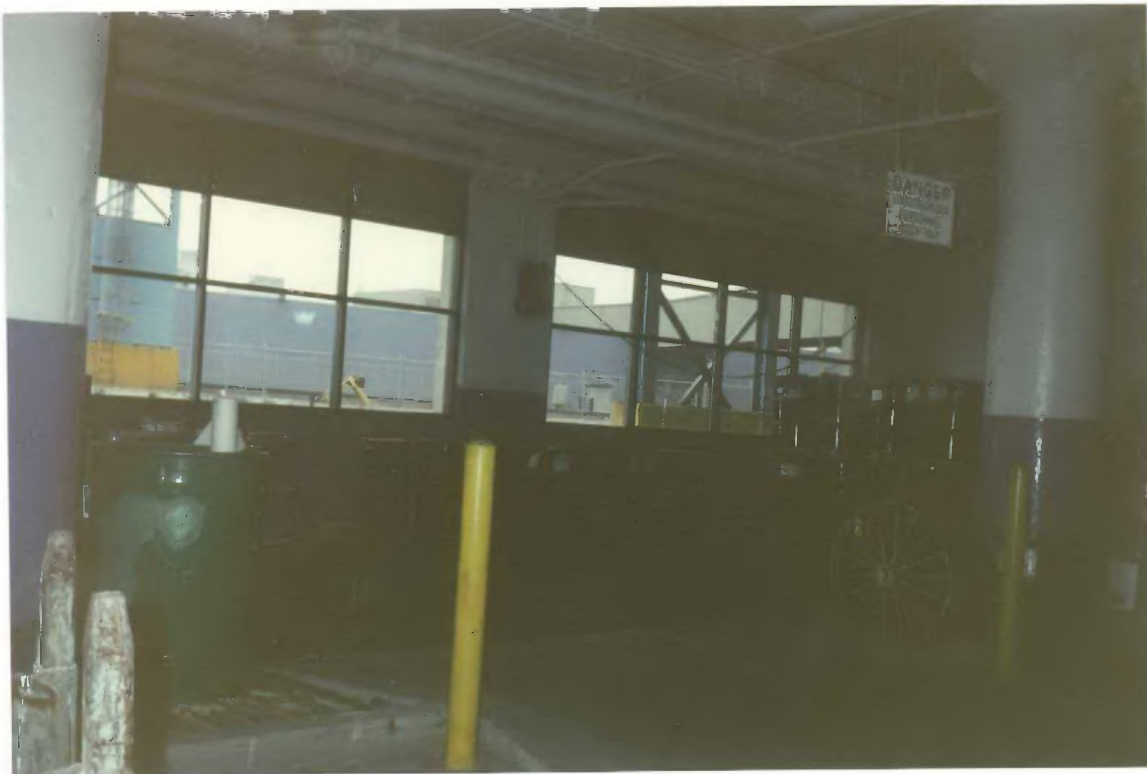
Location: SWMU 2
Date: 11/15/91

Observations: No evidence of spills were observed inside or outside the accumulation area. The floor was not cracked.

Photograph No. 3
Orientation: South
Description: View of current hazardous waste accumulation area

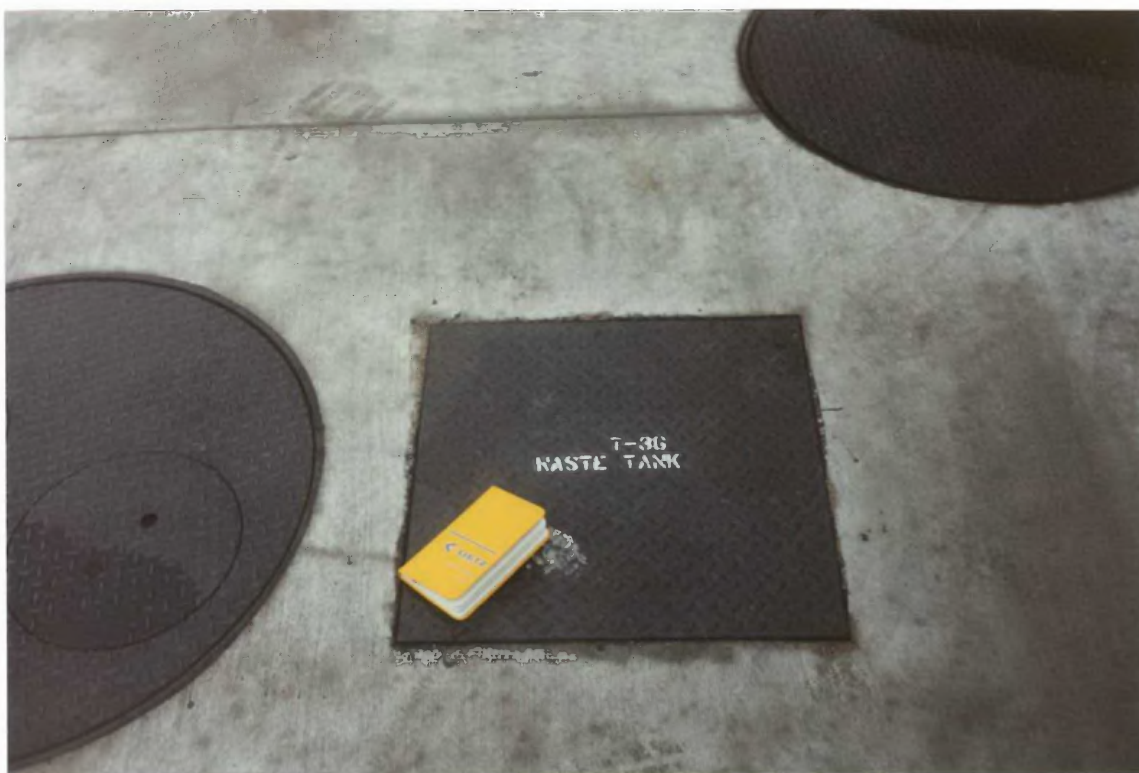
Location: SWMU 3
Date: 11/15/91

History of Release: GMC implemented a program to upgrade UST systems at the Clark Street facility in 1990. In October 1990, GMC notified MDNR of a confirmed release from UST-36 during removal and replacement of the tank system (GMC, 1990j). Visibly stained and odorous soil was noted in the area surrounding the tank's dipstick and fill riser. Because GMC had conducted

a tightness test on UST-36 in December 1989 and found the tank to be tight, they suspected that the source of the release was past overflows at the dipstick and fill riser associated with manual filling of the tank. GMC estimated that approximately 3 to 5 gallons of Stoddard solvent had been released (GMC, 1990h).

Photograph No. 4
Orientation: Unknown
Description: Location of UST-36 that was replaced in 1990

GMC excavated the contaminated soil and disposed of it off site. The tank was removed and replaced with a new tank system having secondary containment during December 1990 and January 1991 (PRC, 1991).

Recommendations: PRC recommends no further action at this time.

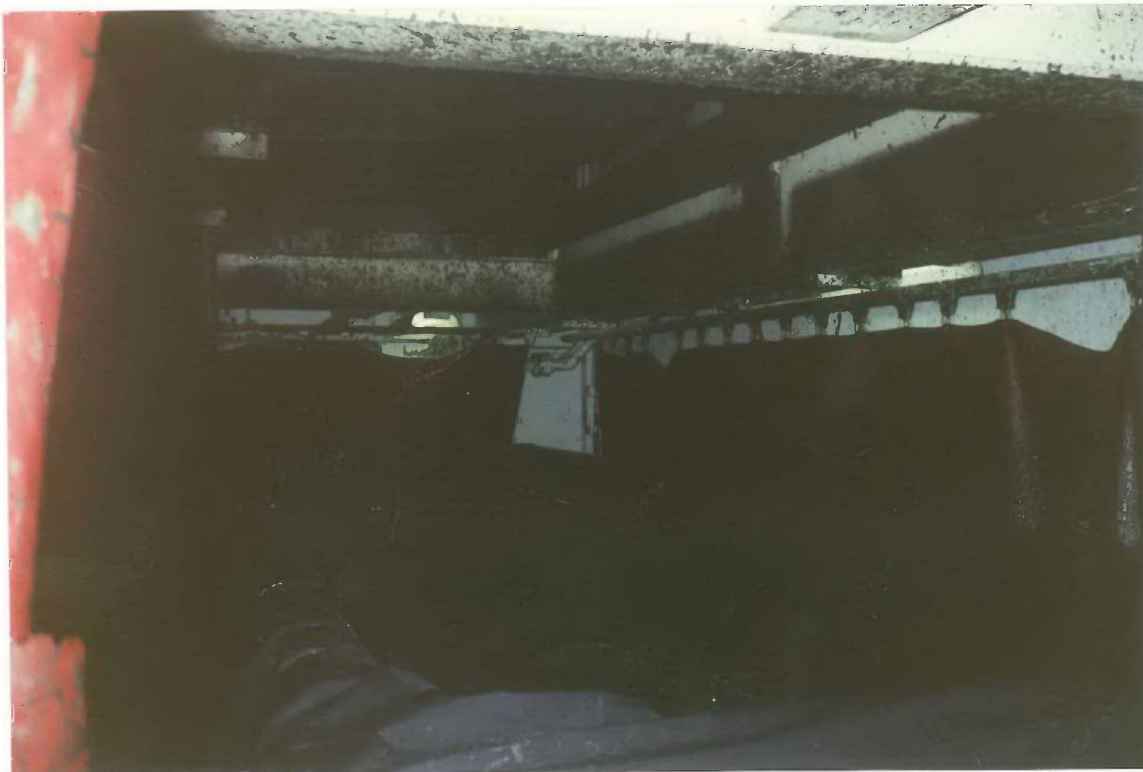
Photograph No.	5	Location:	SWMU 4
Orientation:	Unknown	Date:	11/15/91
Description:	Gondola car containing dewatered treatment sludge; gondola car is located under filter press

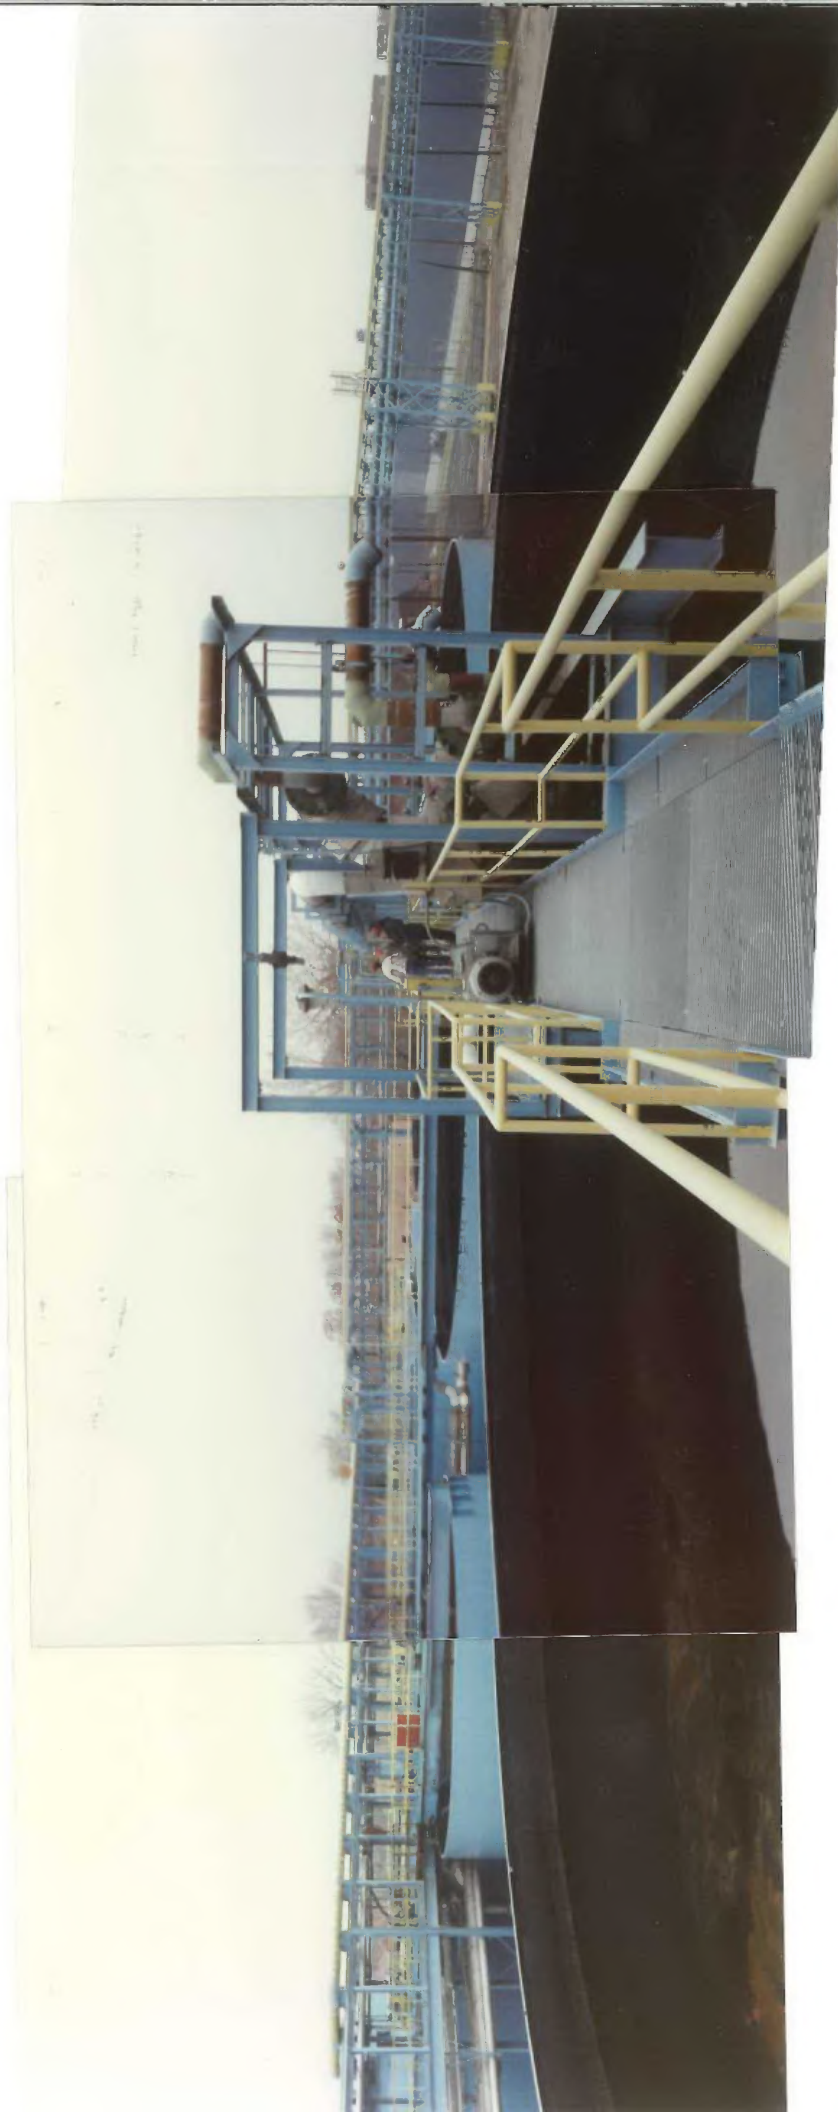
Photograph No. 6 West
Orientation: West
Description: View of wastewater treatment plant; overhead piping (to the right) conveys wastewater from facility operations.

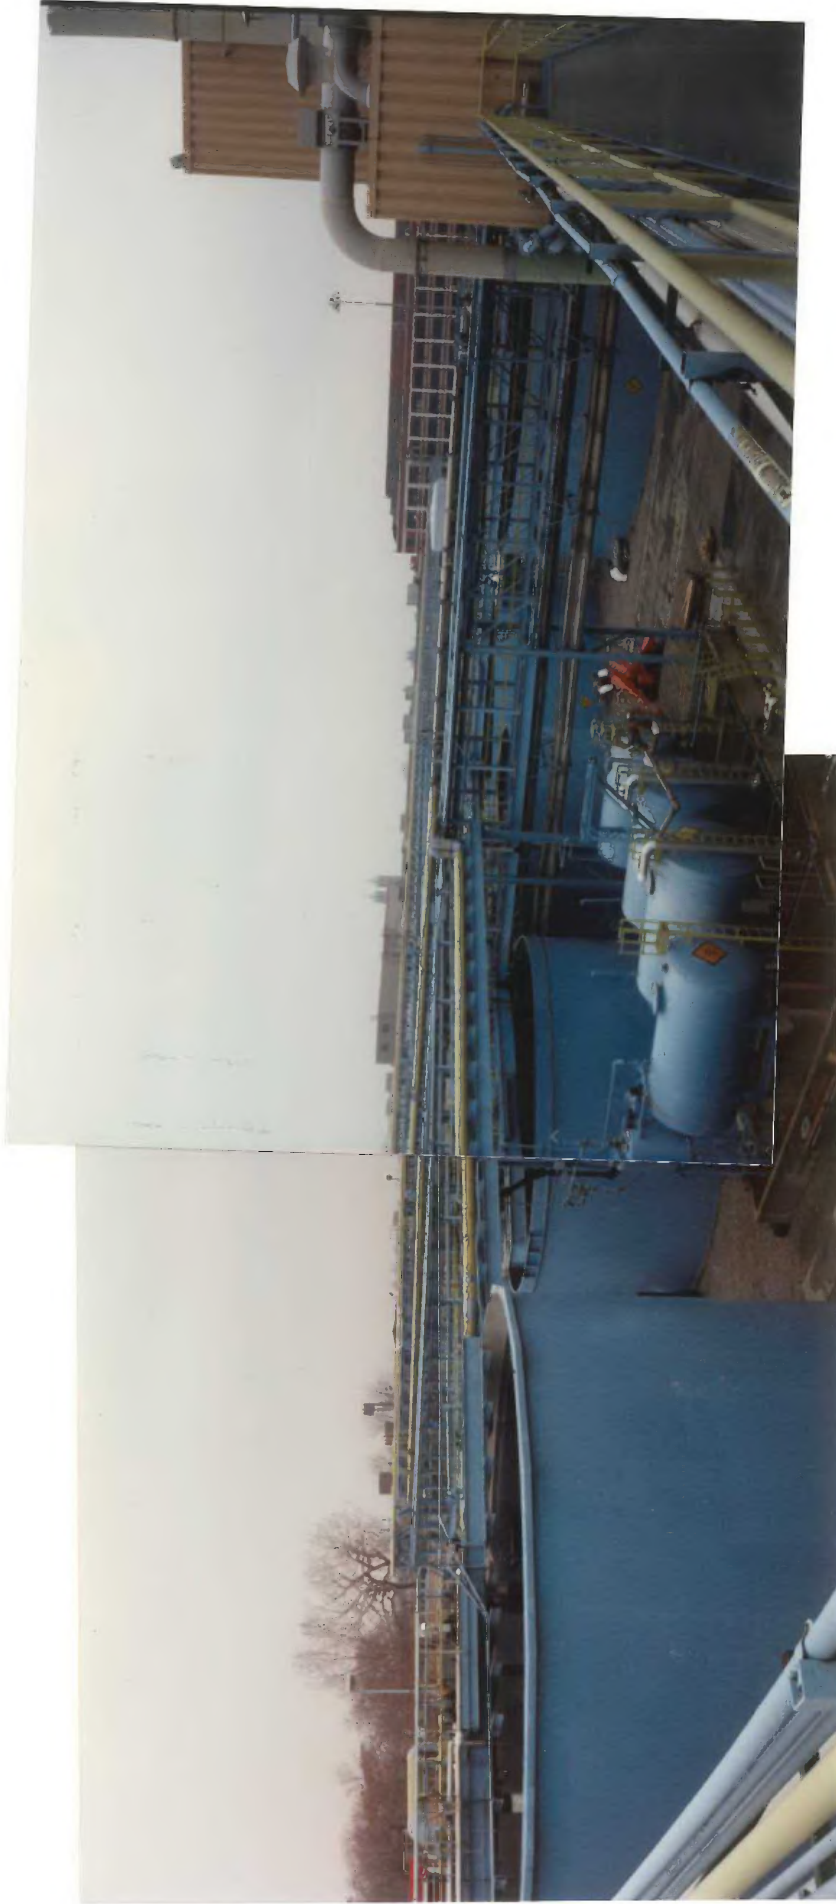
Location: SWMU 4
 Date: 11/15/91

Photograph No. 7
 Orientation: Northwest
 Description: View of wastewater treatment plant

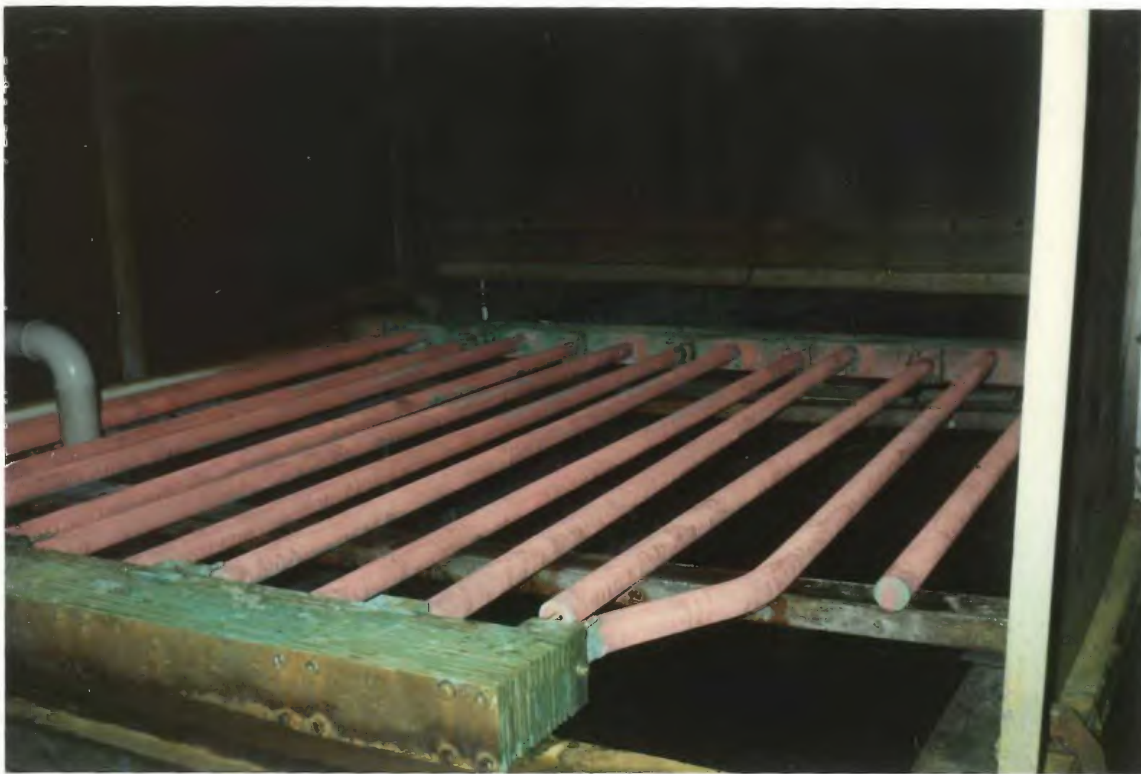
Conclusions: No releases have been documented for this unit. No evidence of spills in the area was noted during the VSI. The tank is inside a building that has paved floors. A hood hangs above the tank to capture any mist generated during its operation. The area under and surrounding the tank has interceptor floor drains that drain to the wastewater treatment plant

(SWMU 4). The potential for the release of hazardous constituents from the copper and nickel reclaim tank to soils, surface water, ground water, or air is low.

Photograph No.	8	Location:	SWMU 5
Orientation:	Unknown	Date:	11/15/91
Description:	Top of copper and nickel reclaim tank inside building that houses plating operations

Recommendations: PRC recommends no further action at this time.

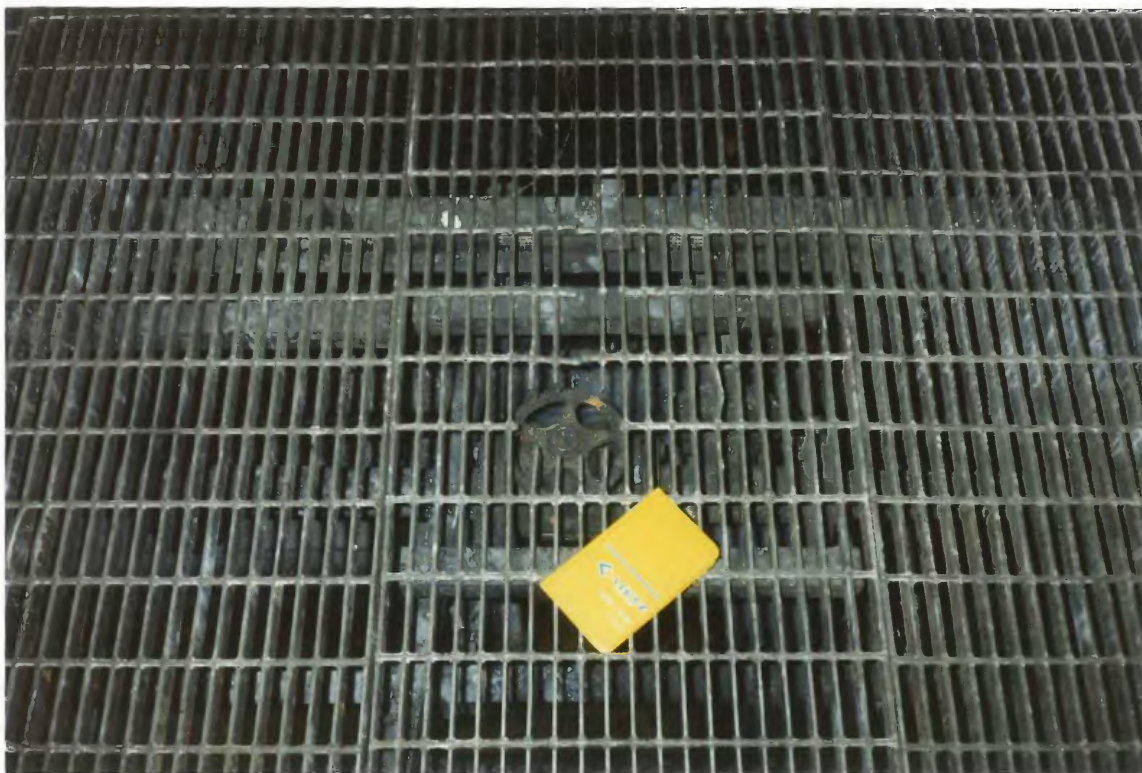
Conclusions: No releases have been documented for this unit. No evidence of spills in the area was noted during the VSI. Drums are rinsed over a pit that is made of concrete and located inside a building. The entire area where drums are rinsed drains to the wastewater treatment plant (SWMU 4). The potential for the release of hazardous constituents from the cyanide drum rinsing station to soils, surface water, ground water, or air is low.

Photograph No.	9	Location:	SWMU 6
Orientation:	Unknown	Date:	11/15/91
Description:	Top of concrete pit where GMC employees rinse drums containing cyanide-bearing plating solutions

Recommendations: PRC recommends no further action at this time.

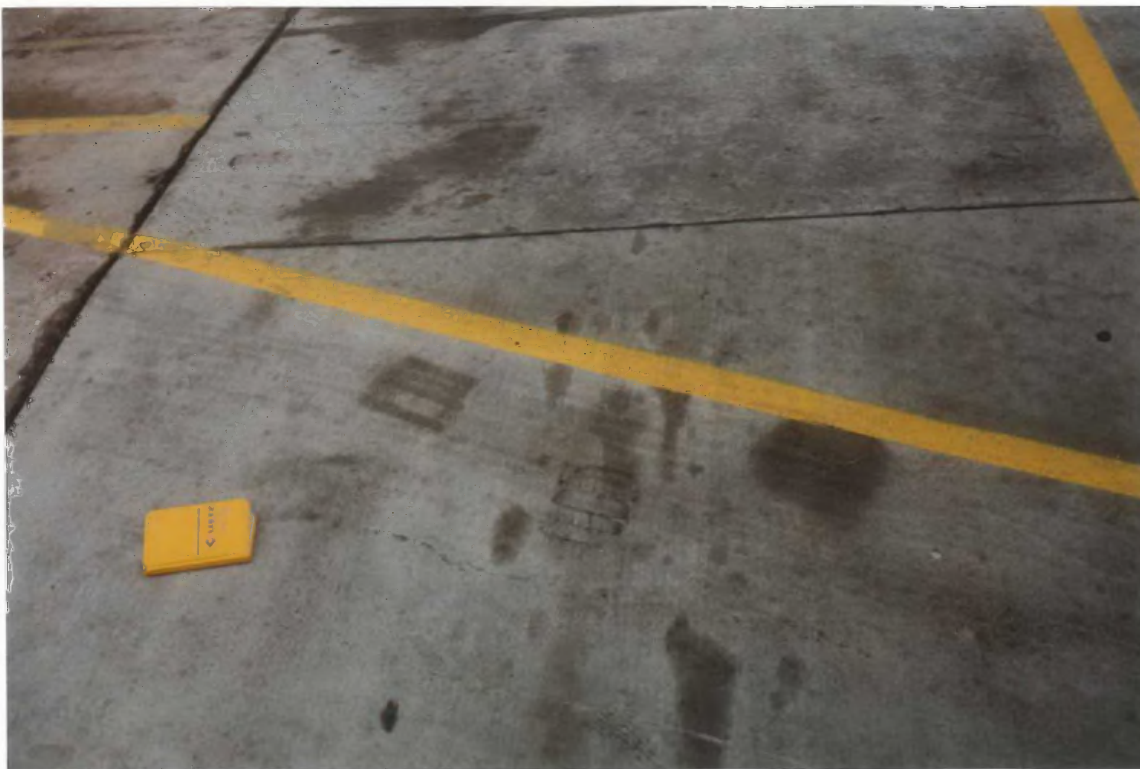
History of Release: Before the tank's removal, GMC suspected a release from the ancillary piping associated with the tank. Upon further soil sampling near the tank, GMC confirmed a release (benzene) to the soils (GMC, 1990i). GMC removed the UST and scrapped it at an off-site facility. GMC also removed 84 cubic yards of contaminated soils and disposed of the soils at an off-site landfill. The excavated area was backfilled with clean sand and the concrete and asphalt cover replaced (GMC, 1991b).

Conclusions: The former underground storage tank released hazardous constituents into the environment. Before the tank's removal, GMC suspected a release from the ancillary piping associated with the tank. Upon further soil sampling near the tank, GMC confirmed a release (benzene) to the soils (GMC, 1990i). GMC removed the UST and scrapped it at an off-site facility. GMC also removed 84 cubic yards of contaminated soils and disposed of the soils at an off-site landfill. The excavated area was backfilled with clean sand and the concrete and asphalt cover replaced (GMC, 1991b). The UST never was replaced. The potential for the release of hazardous

Photograph No. 10 **Location:** SWMU 9
Orientation: Unknown **Date:** 11/15/91
Description: Former location of UST-77; area was repaved after the tank was removed in 1991.

Recommendations: PRC recommends no further action at this time.

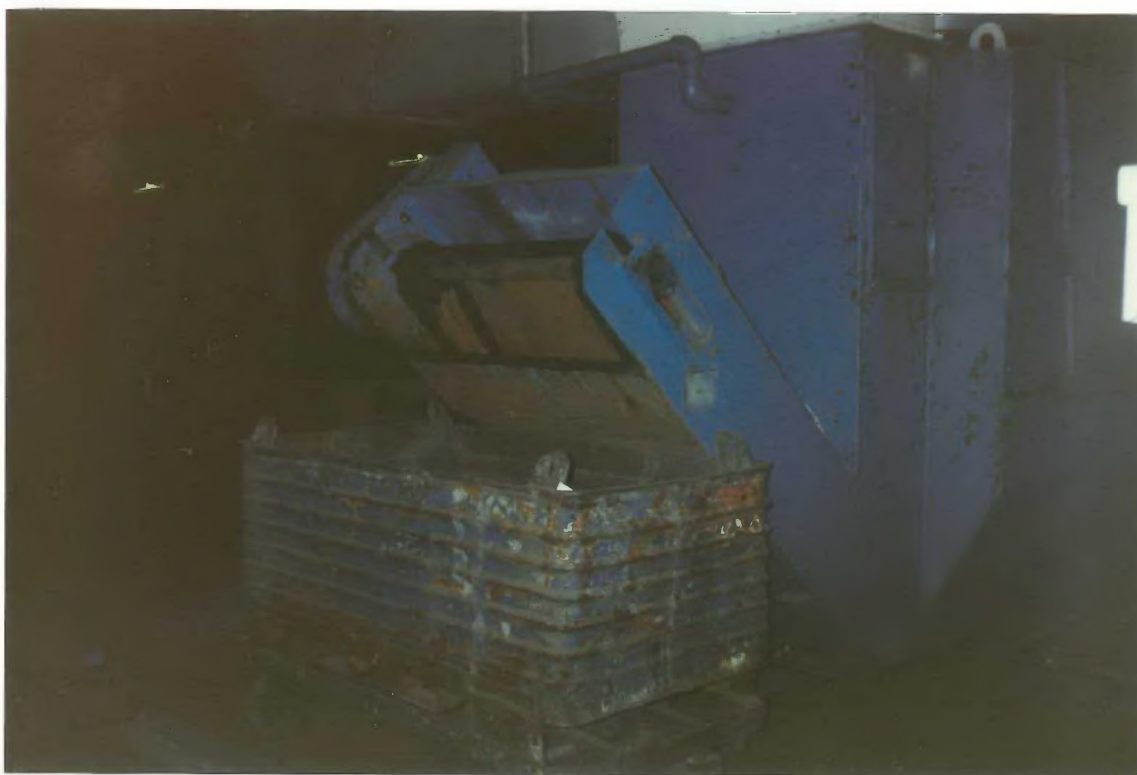
Observations: The scrubber and collection bin appeared to be in good condition. No spills of the scrubber sludge were present around the collection bin. No cracks or fractures were observed in the floor near the unit. The dumpster boxes holding air scrubber dust were covered and appeared to be in good condition. No dust spills were observed near the boxes.

Photograph No. 11 **Location:** SWMU 11
Orientation: Unknown **Date:** 11/15/91
Description: View of air scrubber and collection bin containing dust generated from grinding and buffing bumpers

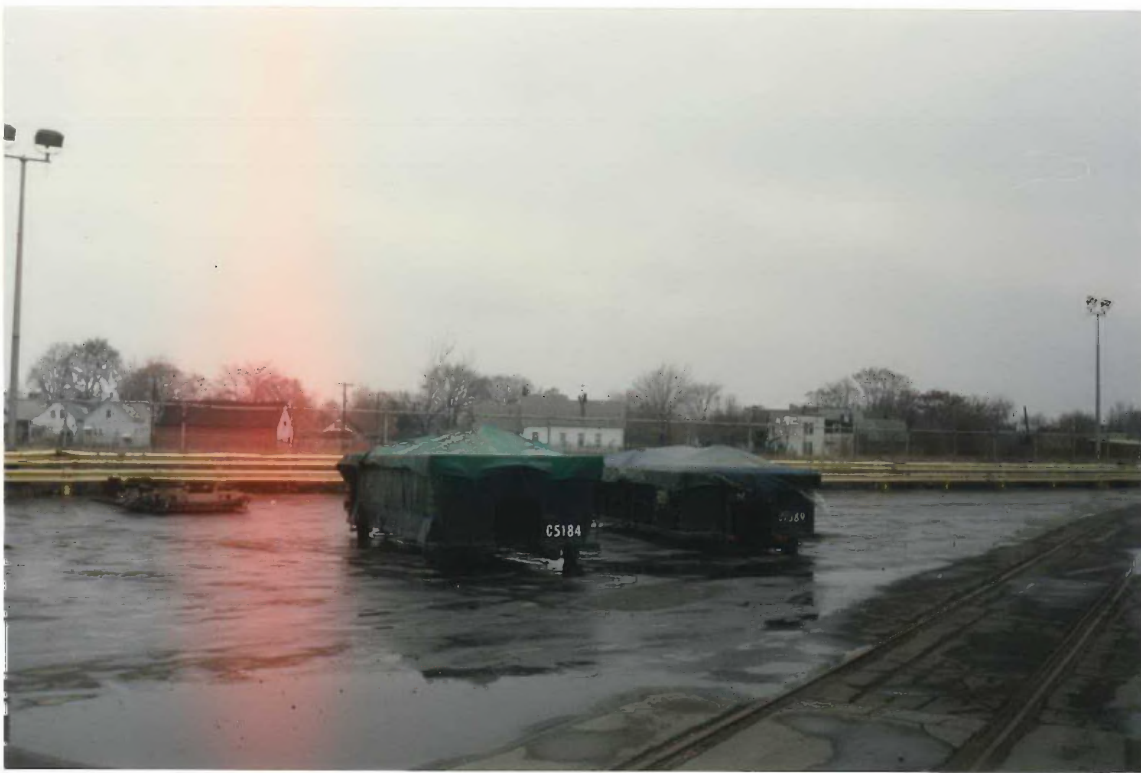
Photograph No. 12
Orientation: North
Description: Dumpster boxes containing air scrubber dusts generated by bumper grinding and buffing operations
Location: SWMU 1
Date: 11/15/91
